**TOXECON™ RETROFIT FOR MERCURY AND
MULTI-POLLUTANT CONTROL ON THREE
90-MW COAL-FIRED BOILERS**

**Quarterly Technical Progress Report
Reporting Period: January 1, 2006 – March 31, 2006
Report No. 41766R08**

**Prepared by
Steven T. Derenne
Wisconsin Electric Power Company
333 West Everett Street
Milwaukee, WI 53203**

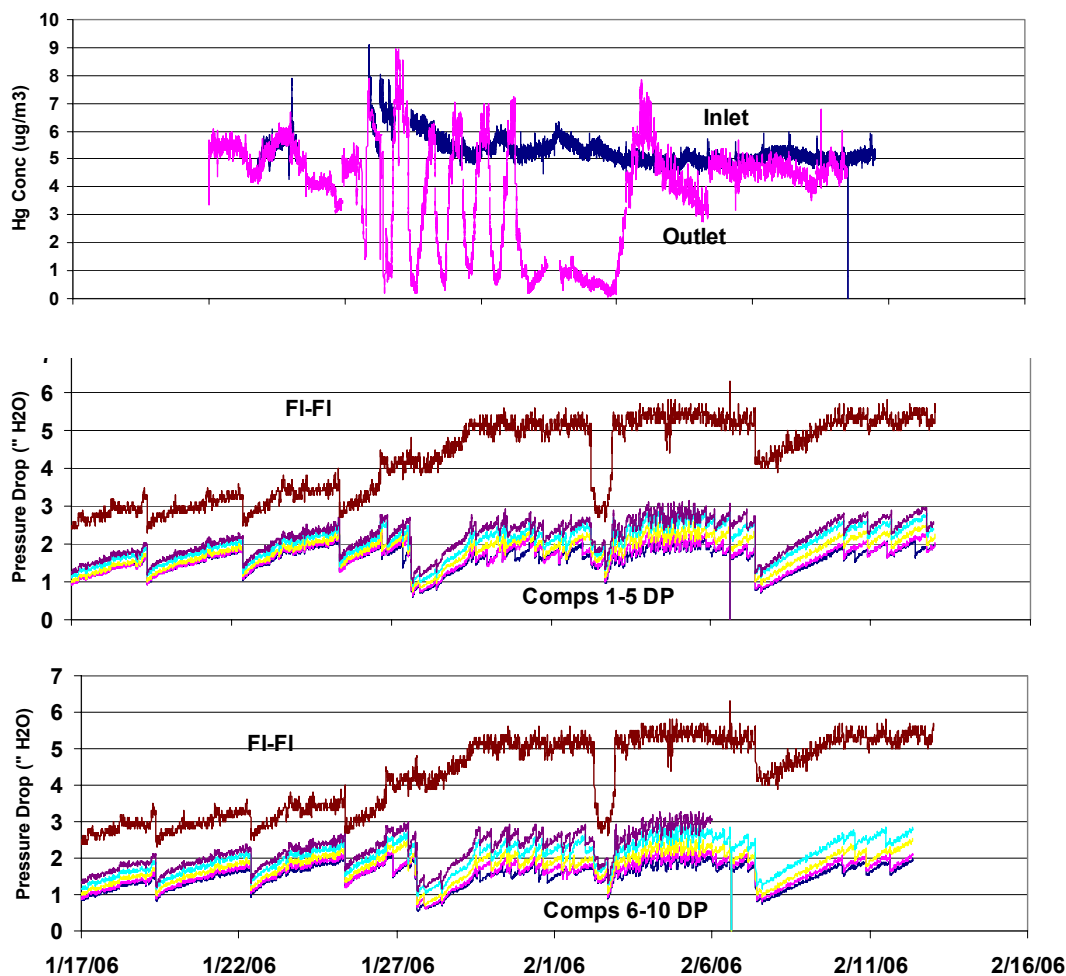
Figure 2. Inlet and outlet mercury concentrations and baghouse pressure drop, January 17 – February 12, 2006.

TOXECON™ testing officially began after check out of the PAC system. Figure 2 shows tube sheet pressure drop for all ten compartments and inlet and outlet mercury concentrations for the time period covering PAC startup and up to baseline testing. The data shows mercury removal during PAC startup and cycling of the PAC feeders as the system was checked out. The data also show that tube sheet pressure drop increases by over a half inch W.C. from the front compartments (1 and 6) to the back compartments (5 and 10). This differential may decrease as the baghouse seasons with continued operation.

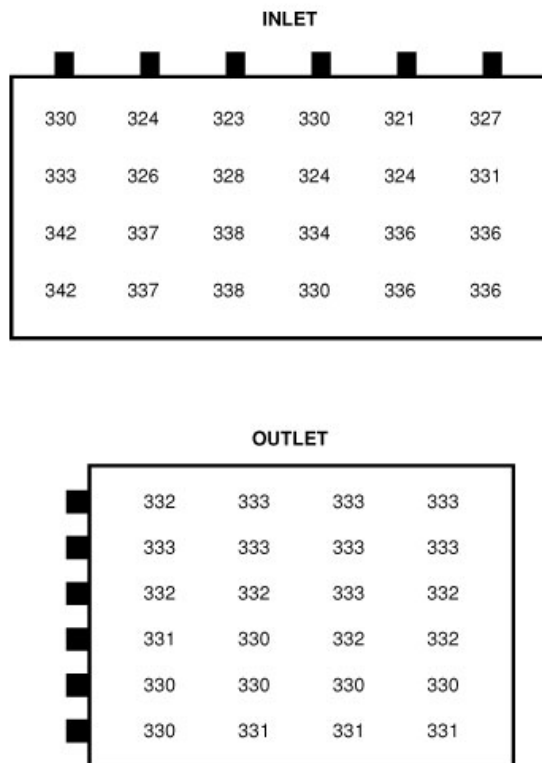
Figure 3. Baghouse Temperature Profile.

During baseline testing GE Energy performed various flue gas measurements. As part of the traverse process for the Ontario Hydro Method, flue gas temperatures were taken at 24 points at both the inlet and outlet duct to the baghouse (Figure 3).

The results and comparison with the plant temperature data from the EDS are shown in Table 2. The overall comparison between the plant data and the GE data shows very little difference between maximum and minimum, especially considering that the GE data was taken in 5 minute intervals and not simultaneously.

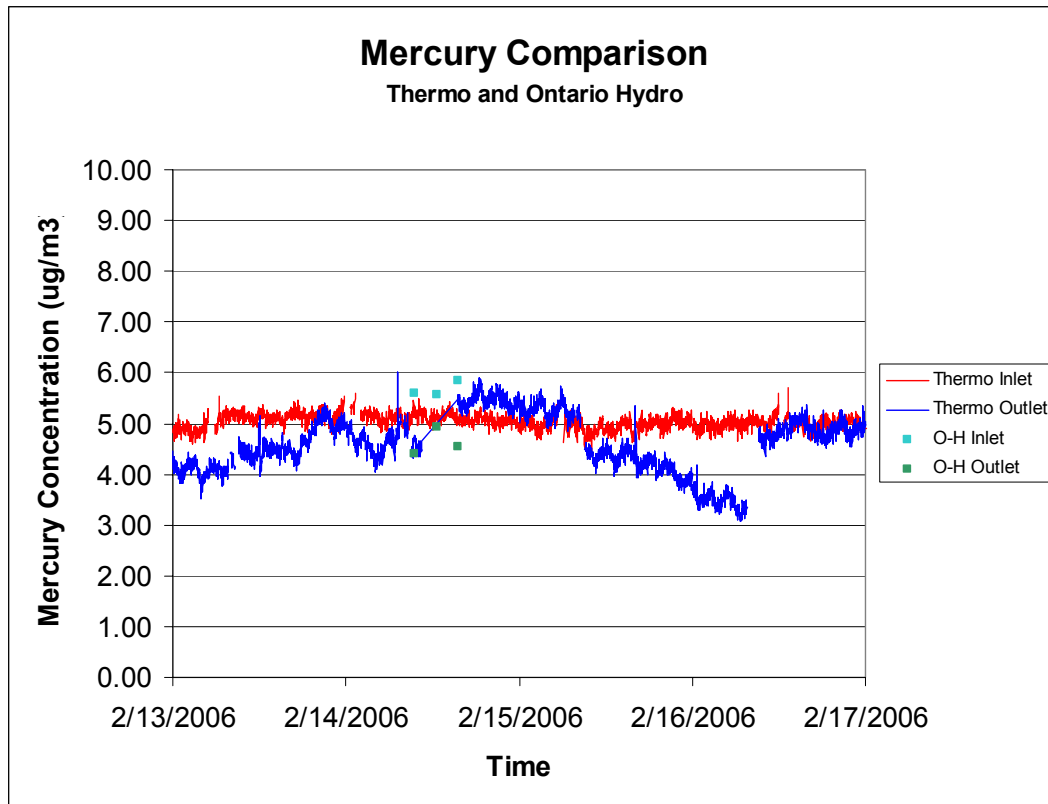
Figure 4. Thermo CEM and Ontario Hydro Measurements

A total of 24 test points were sampled using six ports at the baghouse common inlet and outlet test locations. The speciated mercury sample trains met all specifications required by the Ontario Hydro method. Triplicate tests were performed at the inlet and outlet. Figure 4 shows how the Ontario Hydro measurements compare with the Thermo CEM.

Table 5 shows the average inlet and outlet measurements from 10 am through 4 pm using the Thermo CEM and comparing with the Ontario Hydro Method. There was a 0.6% difference between inlet and outlet based on the CEM, but 9% when using the Ontario Hydro Method. The CEM and the Ontario Hydro results differed by 12% and 4.6%, which is well within the 20% agreement required by EPA to pass the Relative Accuracy Test Audit (RATA) for mercury.

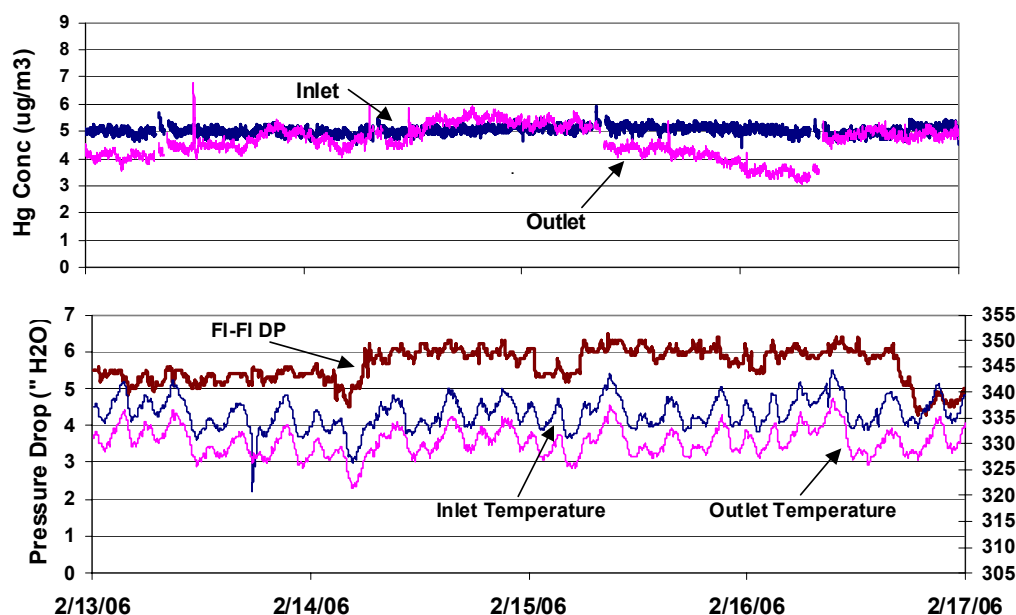
Figure 5. Inlet and outlet mercury concentrations and baghouse pressure and temperature, February 13 – February 17, 2006.

Data was downloaded from the Thermo CEMs and the EDS for the week of baseline testing. Figure 5 shows inlet and outlet mercury concentrations, flange-to-flange pressure drop and inlet temperature. There was some drift on the outlet CEM because the calibration routine was not programmed properly. When this was corrected and the instrument began undergoing daily calibrations, the mercury levels returned to the expected values.

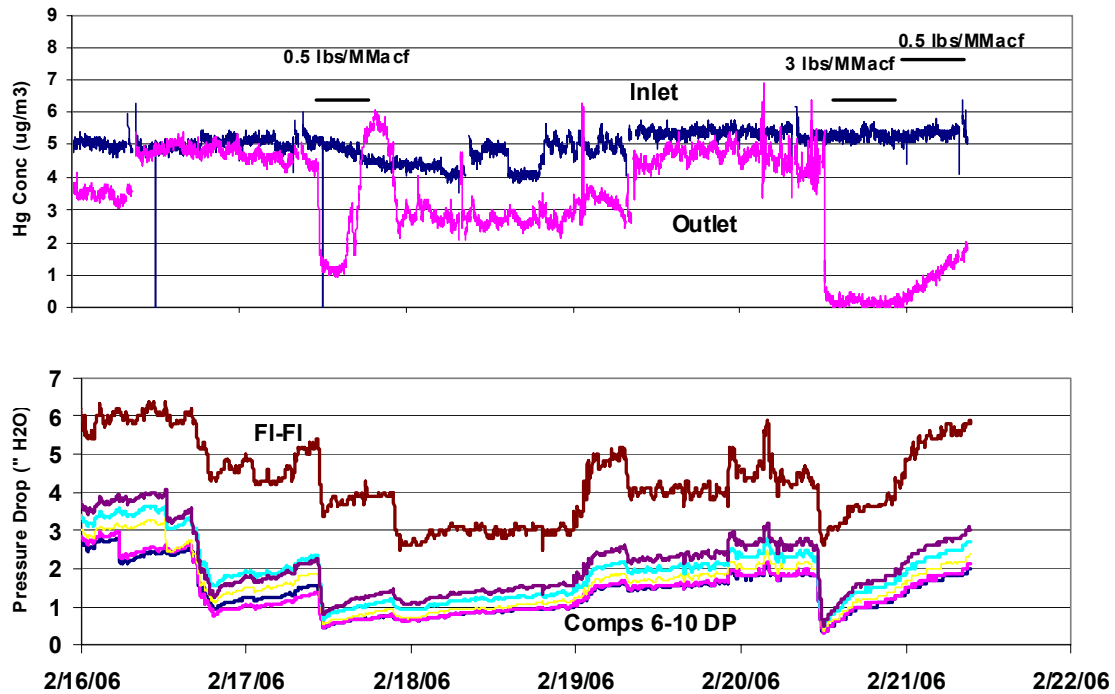
Figure 6. Inlet and outlet mercury concentrations and baghouse pressure drop, February 16 – February 21, 2006.

Prior to parametric testing, the baghouse was put through one complete cleaning cycle to remove residual dust cake that was formed when the units were being brought on line. This was done by initiating a manual clean cycle six times to ensure every pipe in every compartment was pulsed. The flange-flange (fl-fl) pressure drop decreased to nominally 4.5 inches W.C.. To increase the fl-fl pressure to the target of 6.0 inches W.C., PAC injection was started on February 17 at 0.5 lbs/MMacf but there were problems with the ash unloader so PAC injection was discontinued over the weekend. On Monday February 20, the injection was resumed at a relatively high rate of 3 lbs/MMacf and then lowered as pressure drop increased. The effect of these injection rates can be seen in Figure 6.

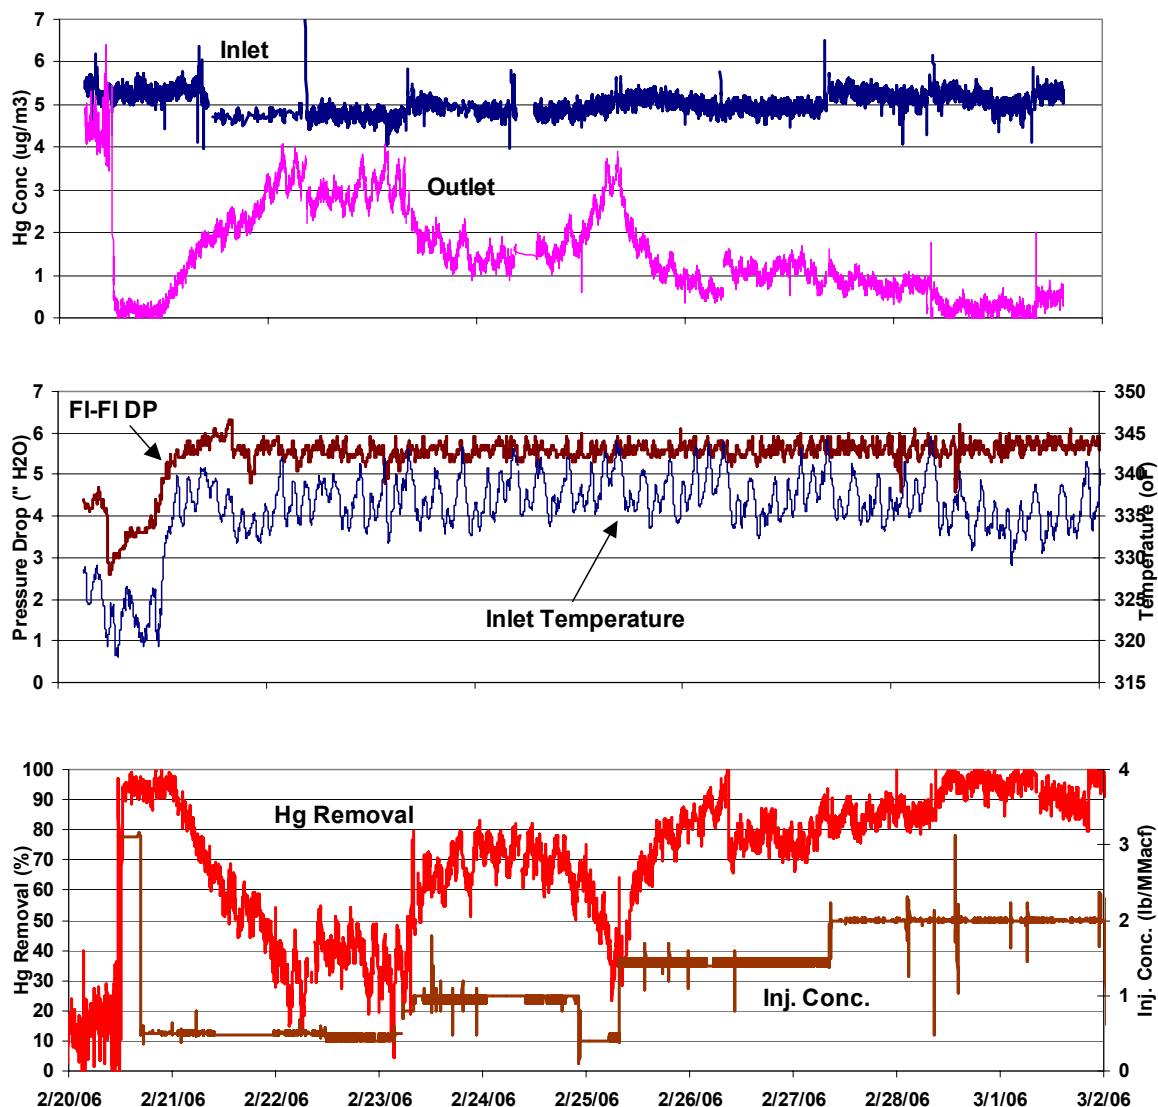
Figure 7. Inlet and outlet mercury concentrations, carbon injection concentration, baghouse pressure drop, inlet temperature and removal February 20 – March 1, 2006.

On February 20 PAC injection was set at 0.5 lbs/MMacf. By February 22, outlet mercury concentration leveled out. This gradual increase in outlet mercury was caused by the residual carbon on the bags from operation at 3 lbs/MMacf. As the carbon capacity was used up, the mercury removal rate decreased until a quasi-equilibrium was reached on February 22. At this condition, outlet mercury cycled between about 2.5 and 4.8 $\mu\text{g}/\text{m}^3$; these changes can be seen in Figure 7. After considering several variables that could affect outlet mercury concentration, including temperature, flow, pressure drop, pulse cleaning, carbon feed and hopper ash pulling, it became apparent that outlet mercury concentration was mainly varying with inlet flue gas temperature.

Because of the significant and unexpected, but consistent variation in outlet mercury with temperature, the criteria of operating for 24 hours at a removal efficiency (RE) $\pm 5\%$ was waived.

On February 27 the injection concentration was increased to 2.0 lb/MMacf. The average RE was nominally 90%, but varied between 80 and 95%.

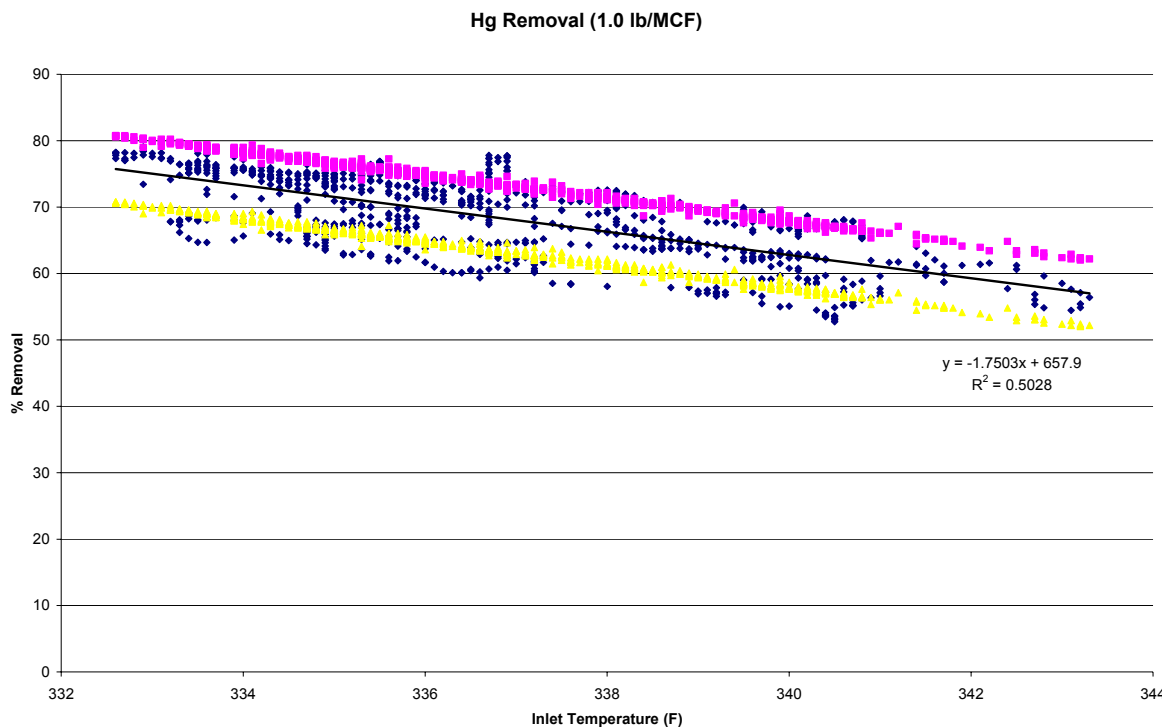
Figure 8. Linear regression showing relationship between inlet temperature and mercury removal efficiency and $\pm 5\%$ band.

The relationship between mercury removal and inlet temperature during testing at 1 lb/MMacf can be seen in Figure 8. The cycling pattern of inlet temperature and the similar pattern for outlet mercury concentration are illustrated in Figure 9.

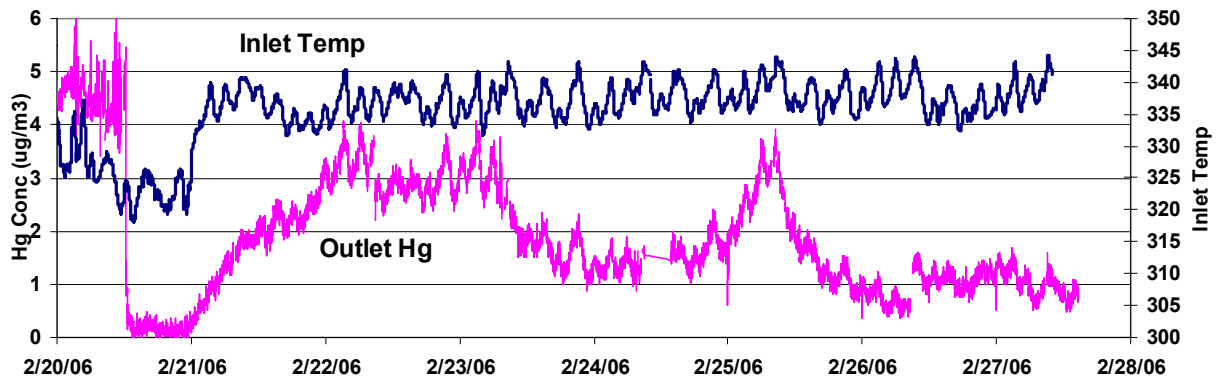
Figure 9. Inlet Temperature and Outlet Mercury Concentration.

The obvious and instantaneous response in outlet mercury concentration to changes in inlet temperature is surprising, especially in the magnitude of the change: a 10°F increase in temperature appears to result in up to a 1 µg/m³ increase in mercury. We do know that this temperature range, 333 – 350°F, is where DARCO Hg begins to lose its ability to adsorb mercury so it is possible that we are just seeing the sensitivity in performance as temperature increases. Another factor is that as temperatures increase, mercury desorbs from the sorbent (activated carbon or ash) until a new equilibrium is reached. We believe we saw this during the shake down period when outlet mercury was higher than inlet mercury after carbon injection was stopped.

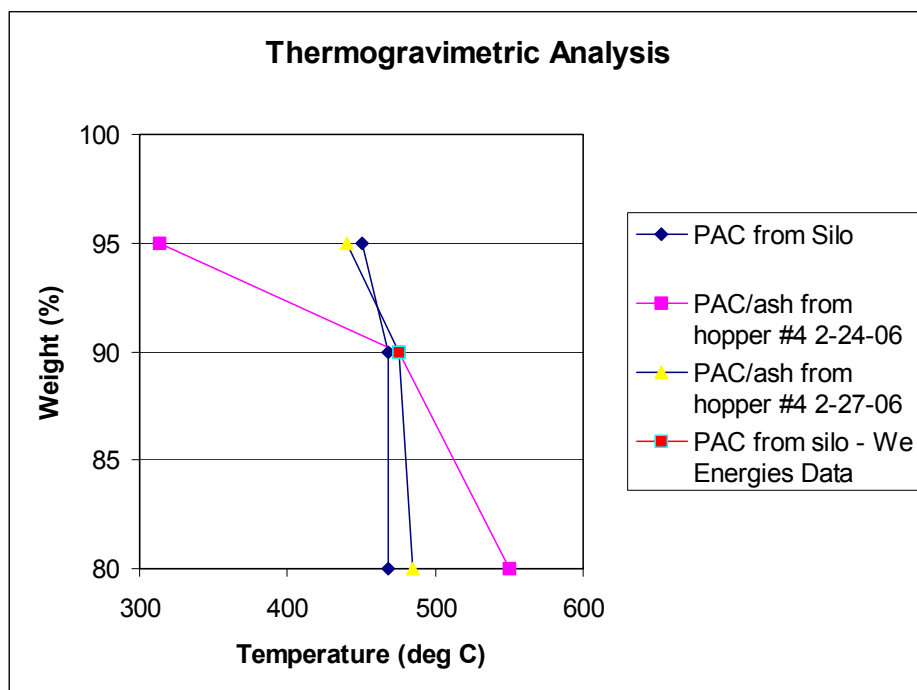
Figure 10. Combustion Temperature Comparison of PAC and PAC/ash

We Energies also performed a TGA on the PAC using nitrogen gas. They found that the pure PAC from the silo lost significant weight at about 475°C, which is similar to the test performed by ADA-ES (Figure 10). The TGA tests were then repeated using air as a purge gas. At 500°F and 550°F, there was no weight loss and no visual sign of embers. Initial sample weight loss began at 720°F and the profile was similar to the test run by ADA-ES.

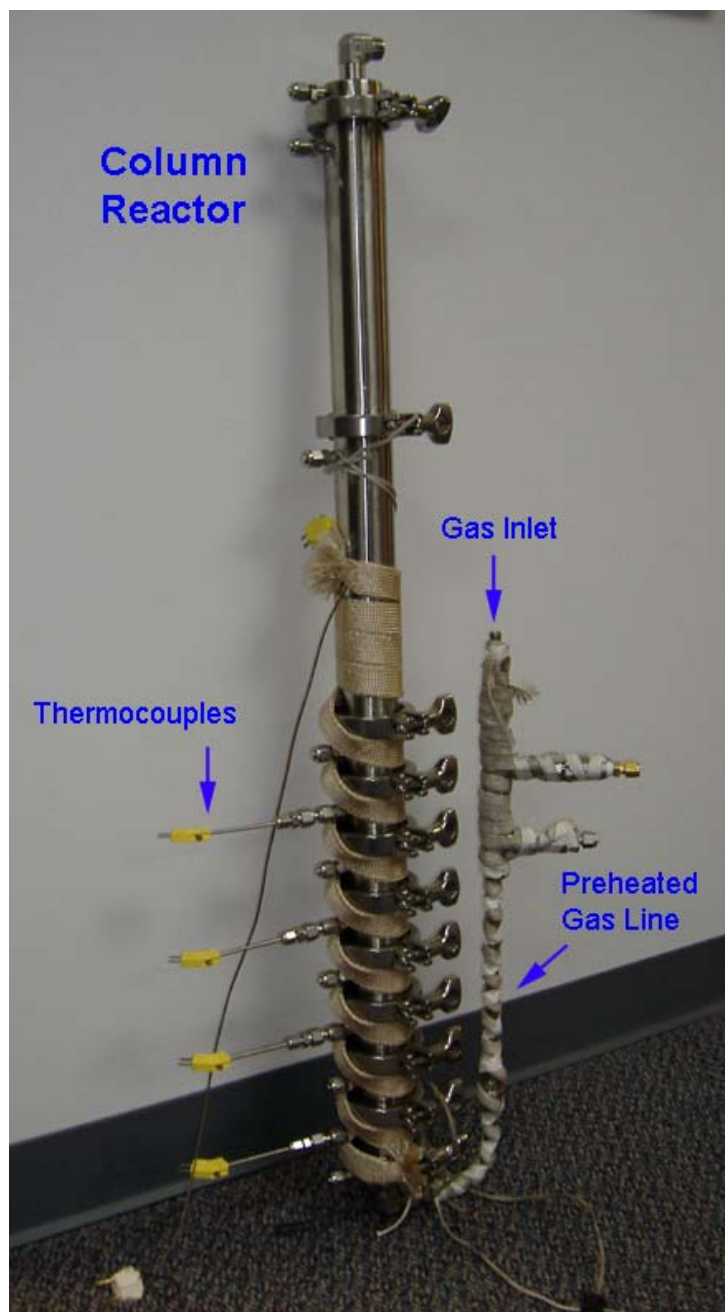
Figure 11. Column Reactor

ADA-ES designed and built a column reactor for testing PAC and PAC/ash to measure any increase in temperature from heat of adsorption. The reactor was 2” diameter stainless steel construction with multiple ports for thermocouples. Figure 11 is a picture of the apparatus.

In this reactor, PAC or PAC/ash would be loaded into the column and gas introduced into the bottom of the column. Multiple thermocouples placed in the center of the bed monitored temperature. Heat tape provided the heat source for the column. The gas entering the column could be heated as needed also.

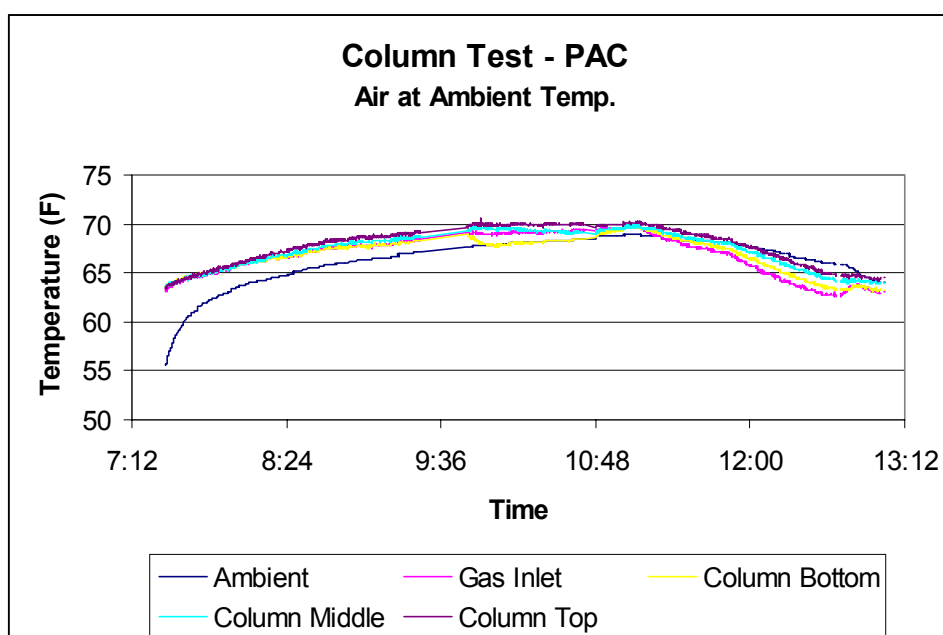
**Figure 12. Column Test - PAC with Air at Ambient Temperature.**

The first test at ambient conditions is shown in Figure 12 and only air showed a minimal temperature rise that corresponded to the ambient temperature increase. This shows that air contact and/or adsorption has no appreciable effect on PAC temperature.

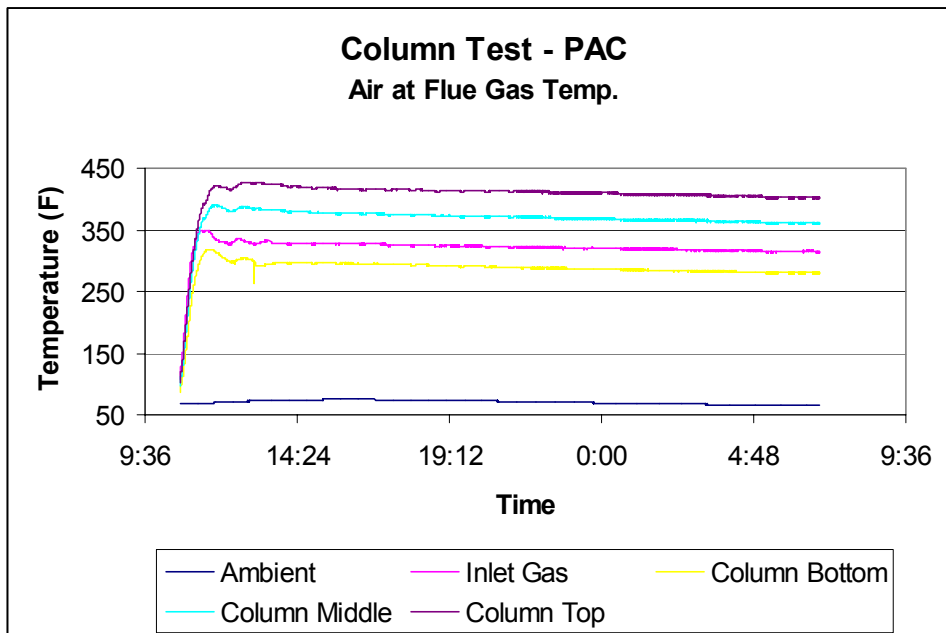
Figure 13. Column Test - PAC with Air at Flue Gas Temperature.

The second test using air at a temperature similar to the flue gas temperature going into the baghouse showed similar results (Figure 13).

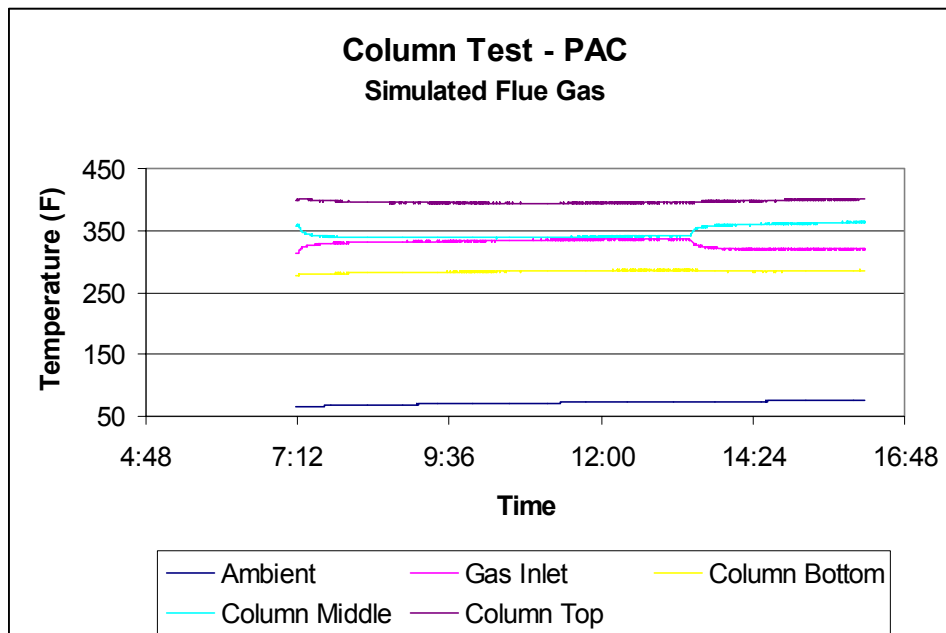
Figure 14. Column Test - PAC with Simulated Flue Gas

Figure 14 shows the results using the simulated flue gas. When the gas flow was terminated, the gas inlet value went down and the temperature in the middle thermocouple went up. Since the other two column thermocouples did not respond, this may have been an anomaly. In general, the PAC did not exhibit any heat of adsorption using the simulated flue gas.

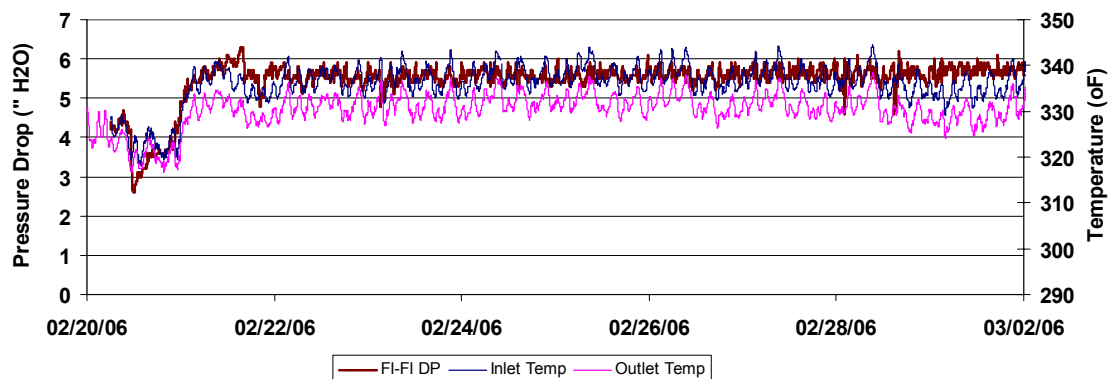
Figure 15. Baghouse Temperature Comparison

A comparison was made of the inlet and outlet baghouse temperatures to determine if there was any indication of overheating. Figure 15 shows inlet and outlet temperatures along with flange-to-flange pressure drop across the baghouse. There did not seem to be any indication of problems with heating or pressure before or during the overheating event.

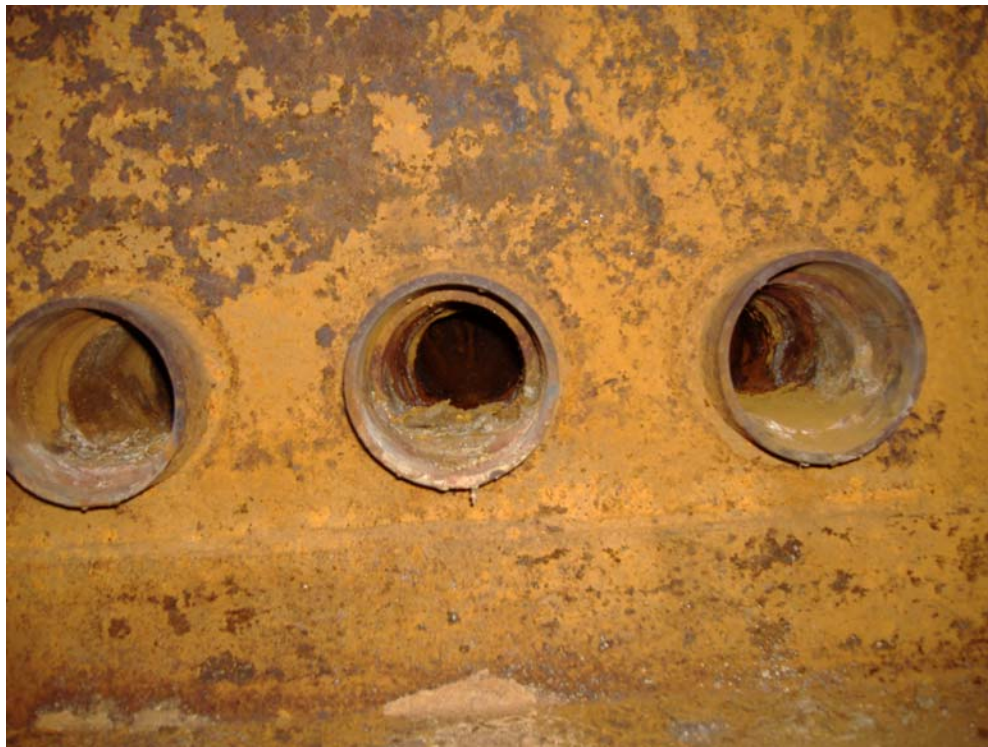
Figure 16. Precipitate in Compartment #1

During the inspection of Compartment #1 the crew noticed that the pulse pipe j-tubes on the exterior wall in section 1B had $\frac{1}{4}$ - $\frac{1}{2}$ " of precipitate near the openings. The precipitate was very hard, brittle, and smelled of sulfur (Figures 16 and 17). Samples were taken and bagged. The majority of the precipitate was at the horizontal run where the tube connected with the pulse pipe. There were also small piles of this precipitate below the connection of the pulse pipes and the j-tubes where this had leaked out from the tube. There was no precipitate buildup in the pulse pipes themselves although there were signs that precipitate-laden liquid had run down some of the cages in the first row near the wall. The j-tubes in section 1A had no noticeable precipitate (Figure 18). The precipitate was cleaned out before the pulse pipes were reinstalled. It is anticipated that this problem will be fixed by adding insulation around the j-tubes where they are external to the baghouse structure. This should be completed during the next reporting period.

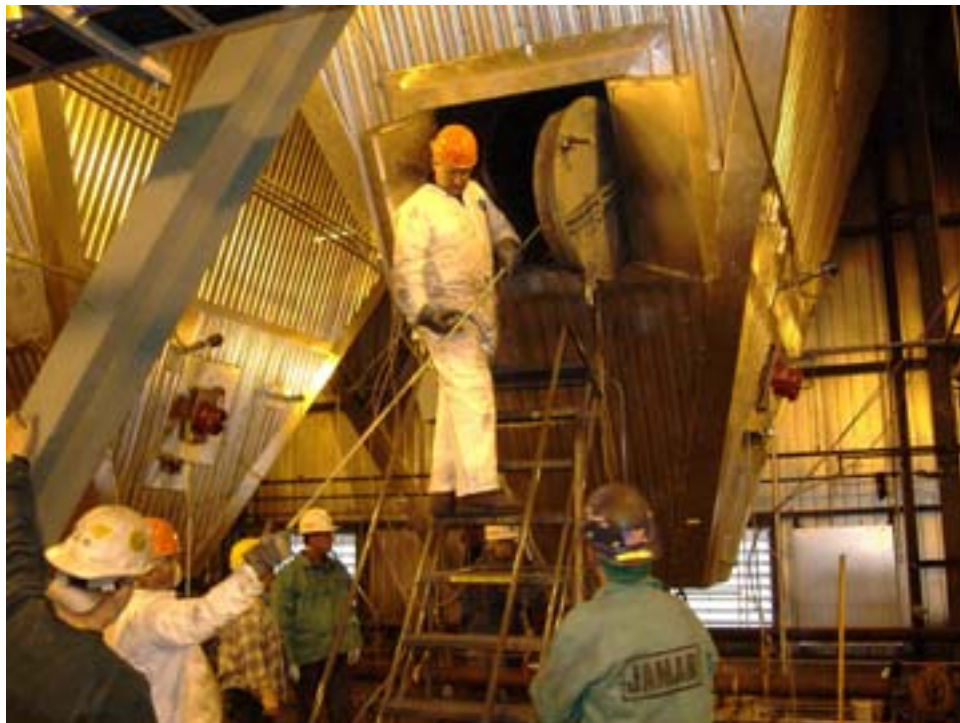
Figure 19. Thermocouples for PAC Bed

On March 30, We Energies performed a test in Compartment #4 hopper. Four thermocouples were welded to each interior hopper wall. These were placed so that they would be 6" below the upper surface of PAC. One thermocouple was also placed between the hottest heater and the outside wall of the hopper. Four thermocouples were wired to metal rods, which were then placed in the PAC bed (Figures 19 and 20). The ends of the thermocouples were located 2.5' above the bottom of the rod.

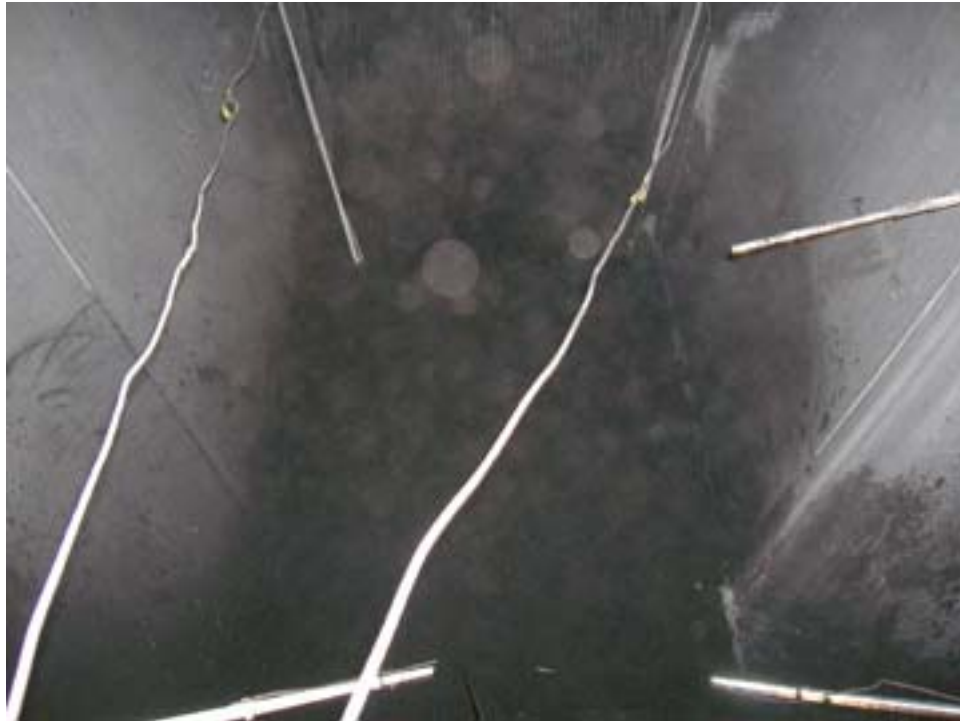
Figure 20. Thermocouples in PAC Bed

A total of 360 lbs of PAC was then loaded into the hopper. This was approximately 4' of material. The hopper heaters were turned on at 12:46 pm. The temperature in the hopper reached approximately 395°F with the rate of increase becoming negligible (Figure 21), so the test was terminated at 3:52 pm. The plan was to start the heaters again when there is flue gas going into the hopper. The maximum temperature reached in the PAC bed was 173°F (Figure 22). The hopper heater control was set to 275°F but the highest indication it gave was 210°F and the heater never cycled off during the test.

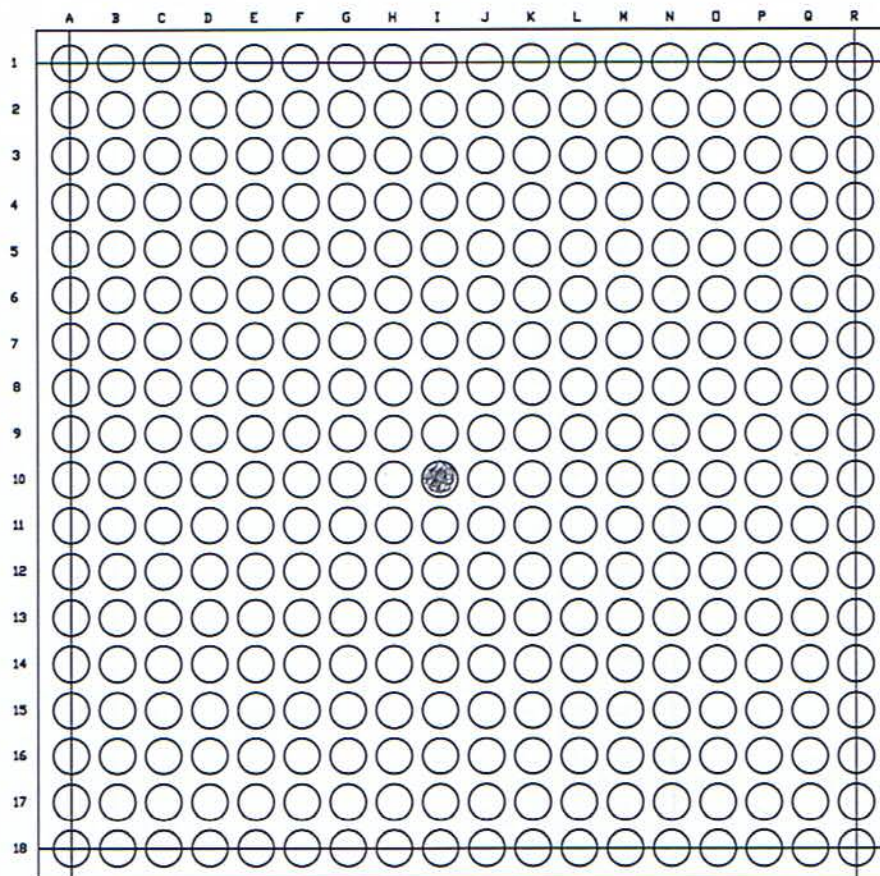
3BI10 was missing bag and bottom section of cage.
Some bags were found to have smaller diameter
collars than others. Samples to be sent out.

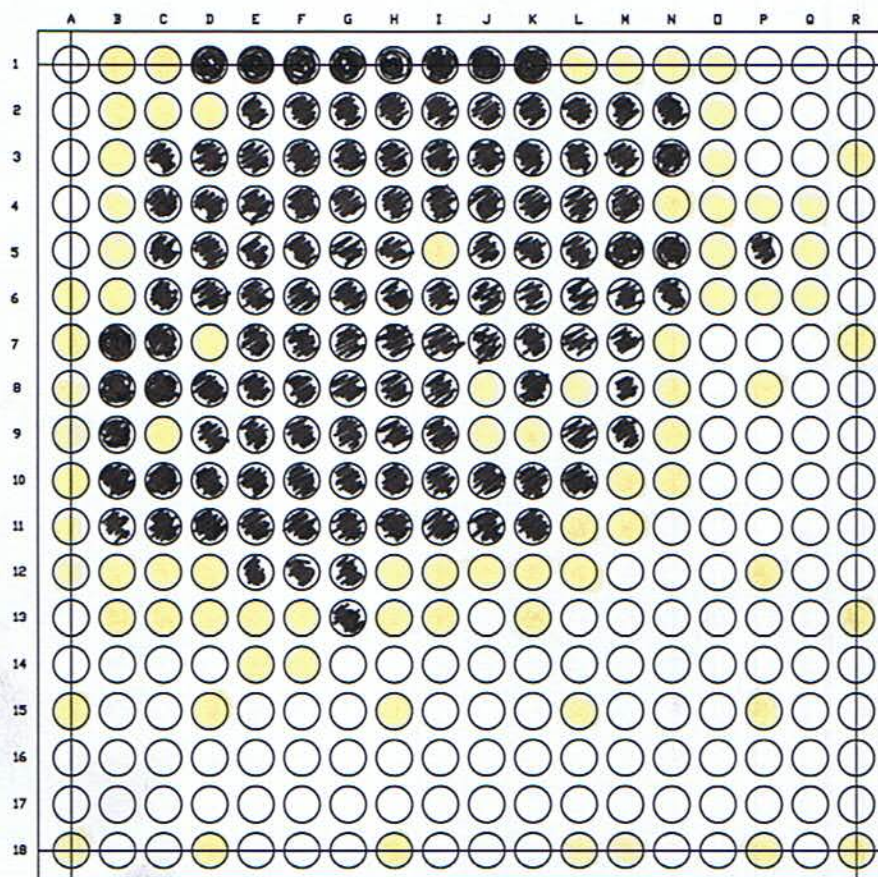
4A5M Burnt bottom
 4A6M Burnt/split up the seam
 4A9M Burnt/split up the seam
 4A2M Burnt bottom

- On 3/7, compartment #4 was opened and inspected. Ash was seen in areas on the tube sheet. Bags were pulled from these areas and many showed melted bag material, especially near the bottom of the bag. The inspection was complete on 3/10. There were 117 failed bags in Compartment 4A and none in Compartment 4B. All compartment inspection sheets are in Appendix C.

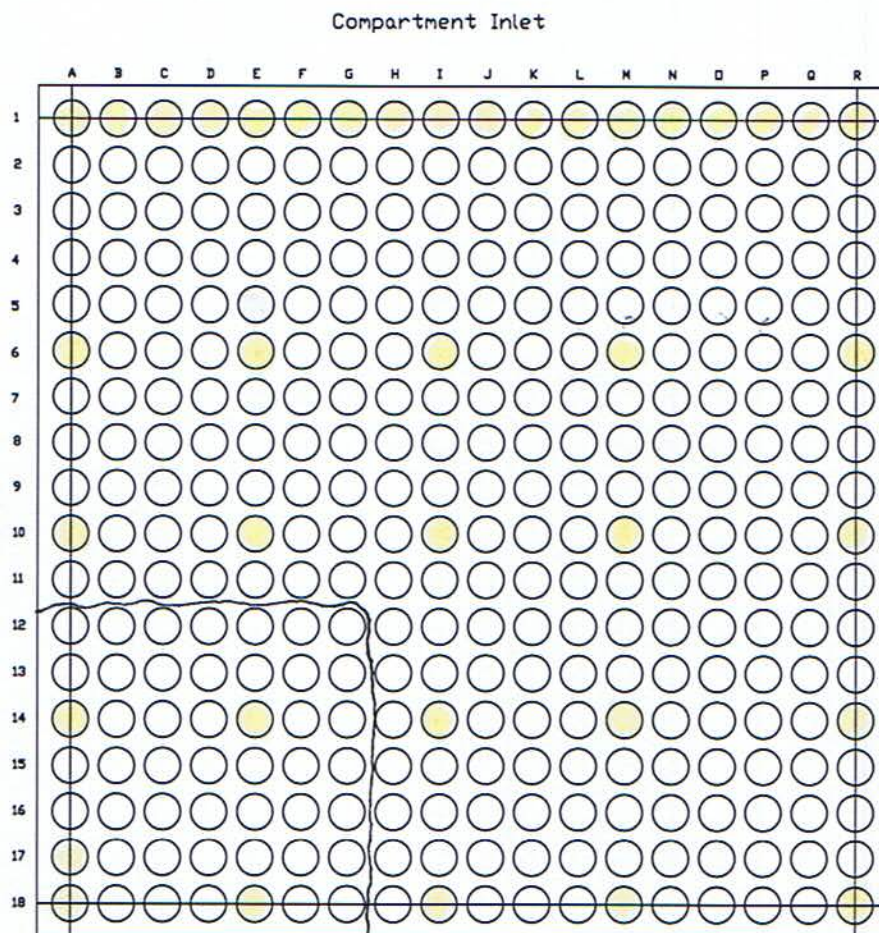
Area where top inside
of bags were discolored
(brown).

Sample: 4B18A was sent
out for testing

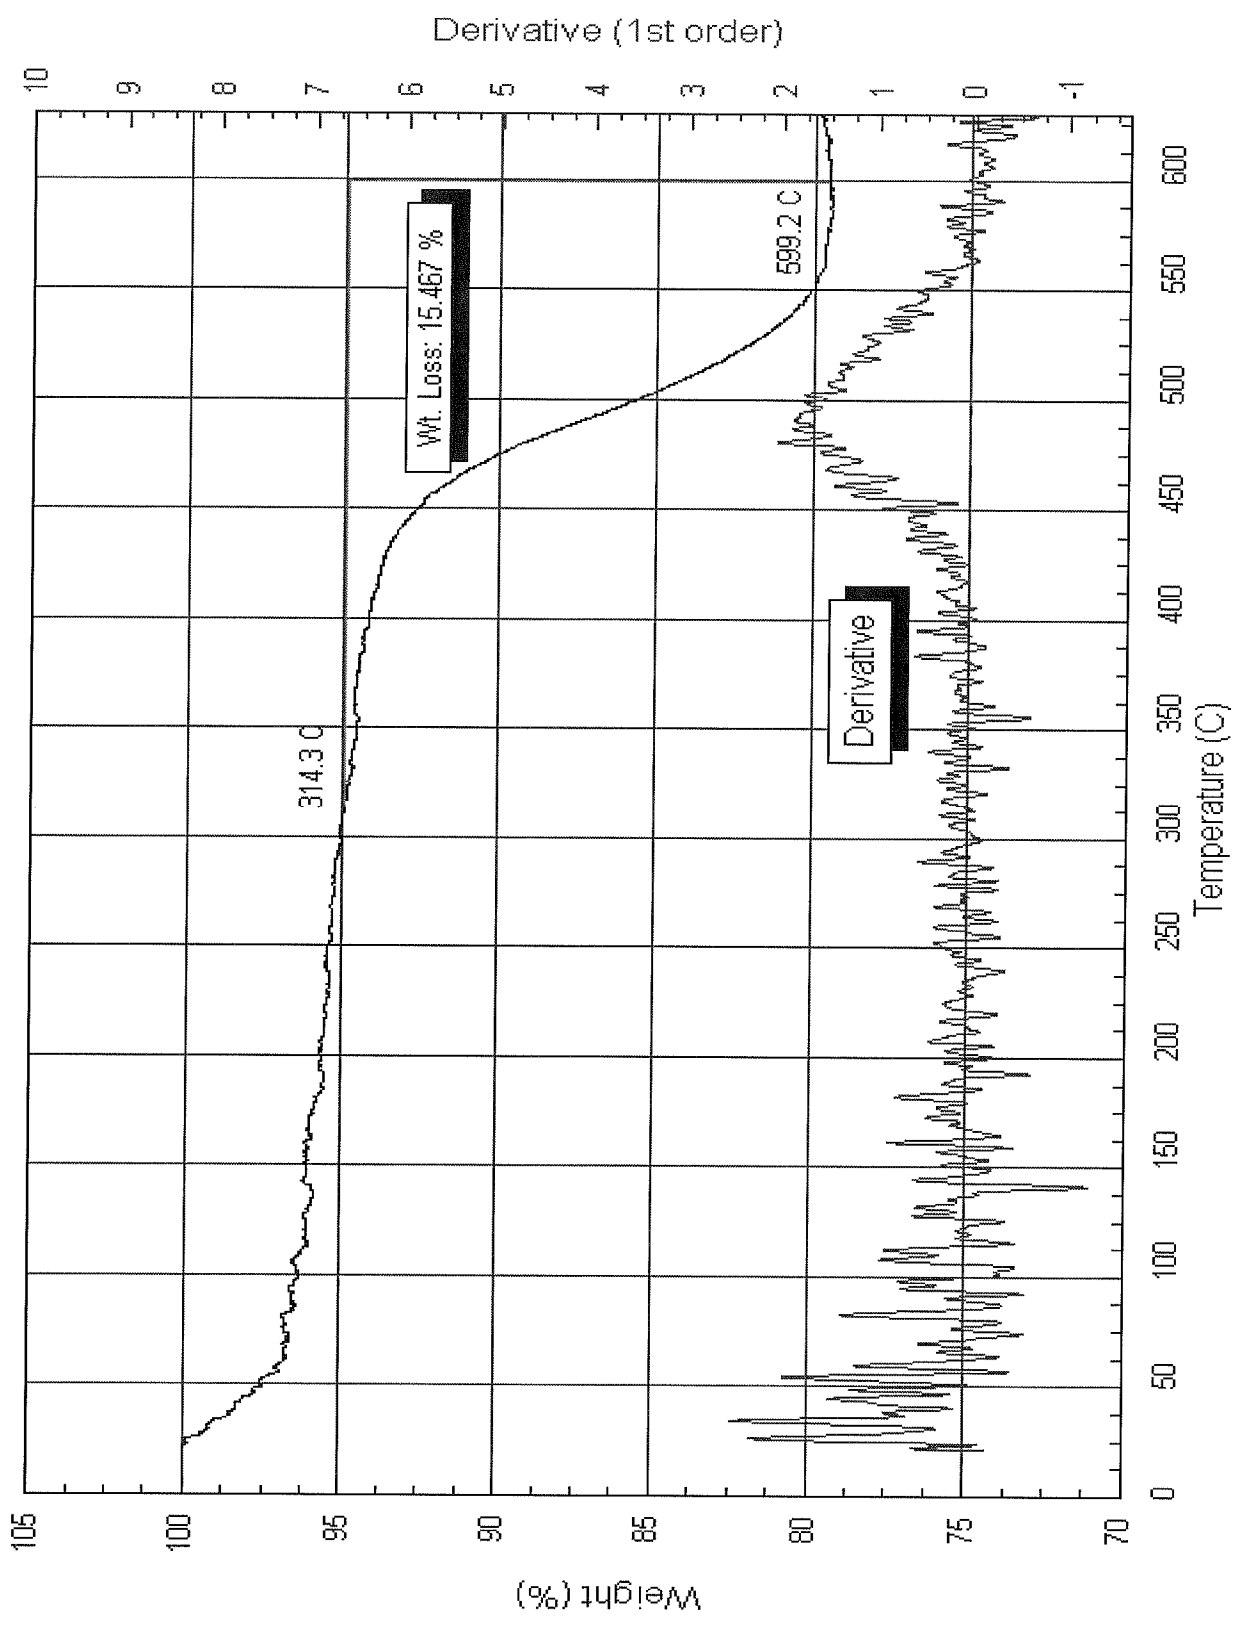
File Name: BH-4_2-24-001.TGA
Size: 10.295
Desc. 1 : ADA-ES; BH-4_2-24-06
Desc. 2 : Purge = Air at 50 cc/min; HR = 10 C/min

Operator: HM
Date: 03/08/2006
Time: 07:16:48
Instrument: TGA 951
